**MINUTES OF MEETING
MEDITERRA
COMMUNITY DEVELOPMENT DISTRICT**

Continued Discussion: M.R.I. Underwater Specialists, Inc. 2020 Drainage Inspection

TO: Mediterra CDD Board of SupervisorsDATE: 06/15/2020FROM: Andy TiltonRE: Brendisi Way Drainage

Outfall ROV Video Inspection

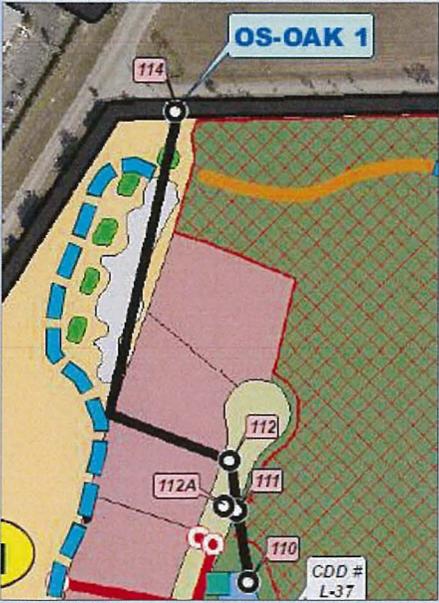
OS Oak1

<p>Findings: The outfall structure appeared to be very clean. The pipes from the outfall going towards the road contained less than 1% sediment. The pipes going from the road to the lake contained 5% sediment with various areas having 10% to 15% buildup.</p>

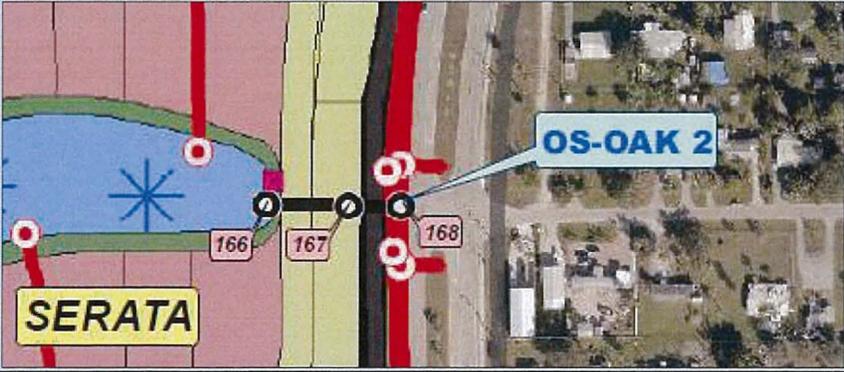
OS Oak2

<p>Findings: The outfall structure and pipe going towards the road were both very clean with little to no sediment present, however, the ROV could not inspect the entire length of the pipe due to inadequate water levels. The pipe approaching the lake contained 30% sediment which thinned out and turned to soft silt as it approached the headwall. Lake bank erosion and sedimentation were visible near headwall.</p>

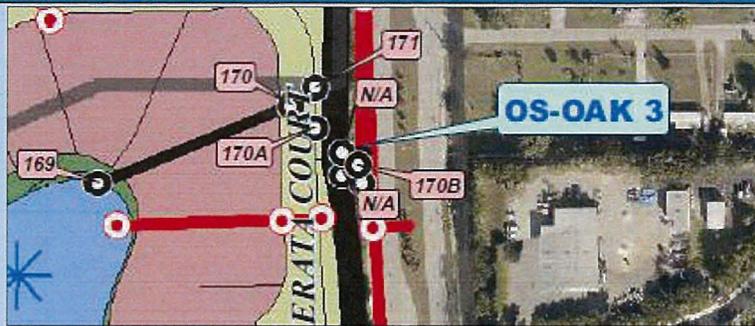
OS Oak3

Findings: The pipe from the road towards the outfall structure ranged from 5% to 20% with sediment. The outfall structure contained minimal sediment, with no obstructions present. The pipe going towards the lake and the headwall contained 10% sediment.

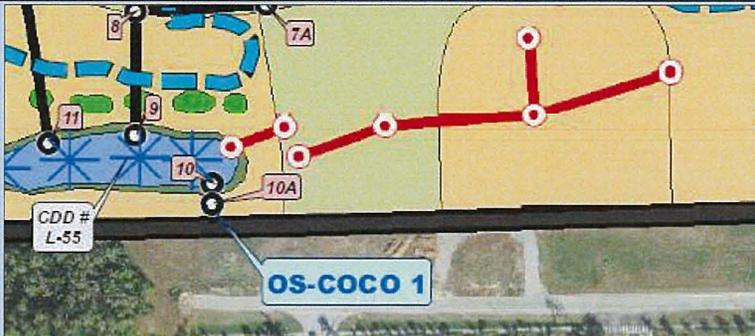
OS Coco1

Findings: Both the outfall structure and headwall appeared to be fairly clean with only mild sediment present. The pipe connecting the two structures contained 5% to 10% sediment for the majority of the length which increased to 30% sediment towards the middle of the pipe and then thinned out again.

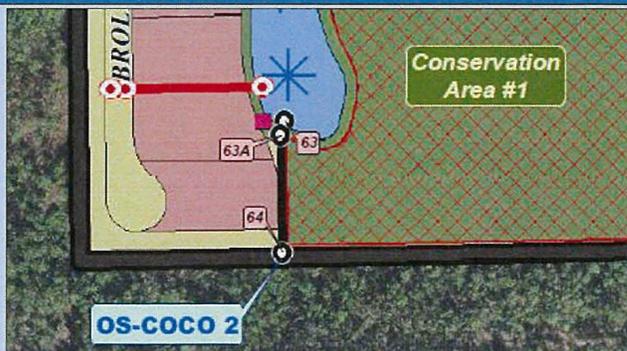
OS Coco2

Findings: Due to the location of the outfall structure the camera trailer was unable to access the area. There was a large amount of trees obscuring the structure and with the wet conditions the camera truck would have become stuck.

The diver entered each structure to physically inspect and scope the lines. Diver found a minimal amount of sediment and debris present with no significant blockages.
