**MEDITERRA**  
**COMMUNITY DEVELOPMENT DISTRICT**  
OFFICE OF THE DISTRICT MANAGER  
9220 Bonita Beach Road, Suite #214  
Bonita Springs, FL 34135

**MEMORANDUM**

Date: April 16, 2025  
To: Mediterra Board of Supervisors  
From: Shane Willis – Operations Manager  
Subject: Quality Assurance Inspection – Lake Maintenance  
Cc: File

# STORMWATER QUALITY ASSURANCE INSPECTION

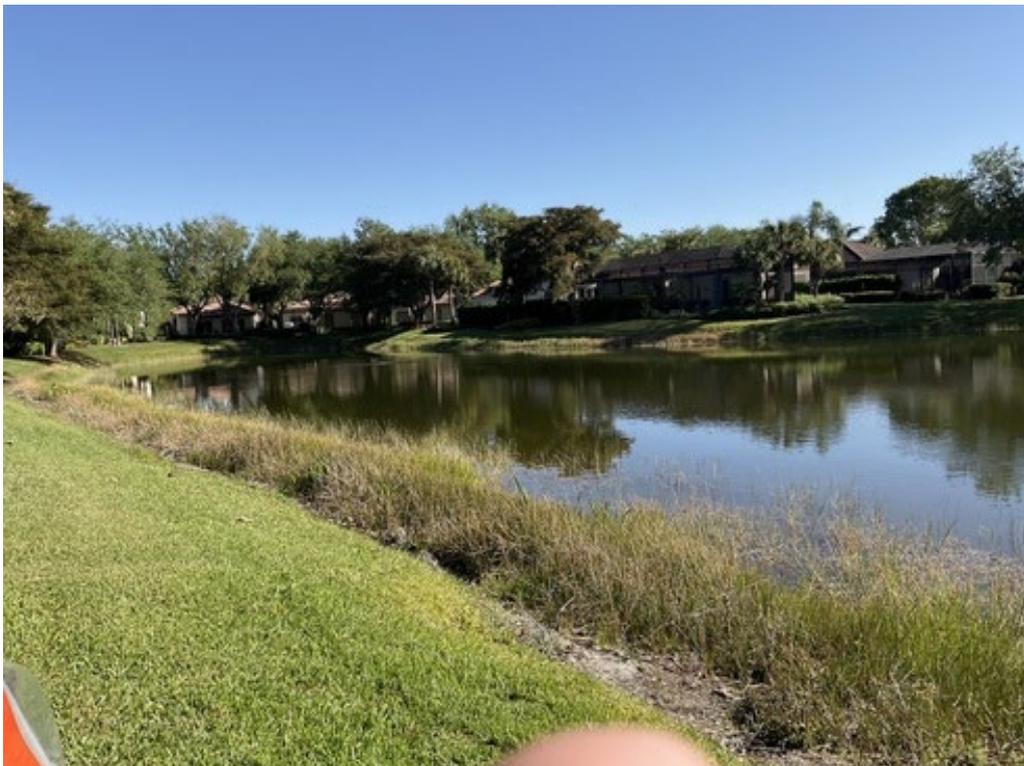
Photo 1

AUDIT CHECK POINTS	
Does invasive/undesirable plant control meet contract specifications? <b>Minor Bank Weeds, Weeds in Rip Rap</b>	Yes
Does beneficial plant population meet regulatory requirements?	Yes
Are existing beneficial plants healthy?	Yes
Is the lake absent trash?	Yes
HEALTH/SAFETY	
Is the lake surface absent any oil, grease or gas sheen?	Yes
Wildlife Observed	Anhinga
Does the overall lake body appear healthy?	Yes

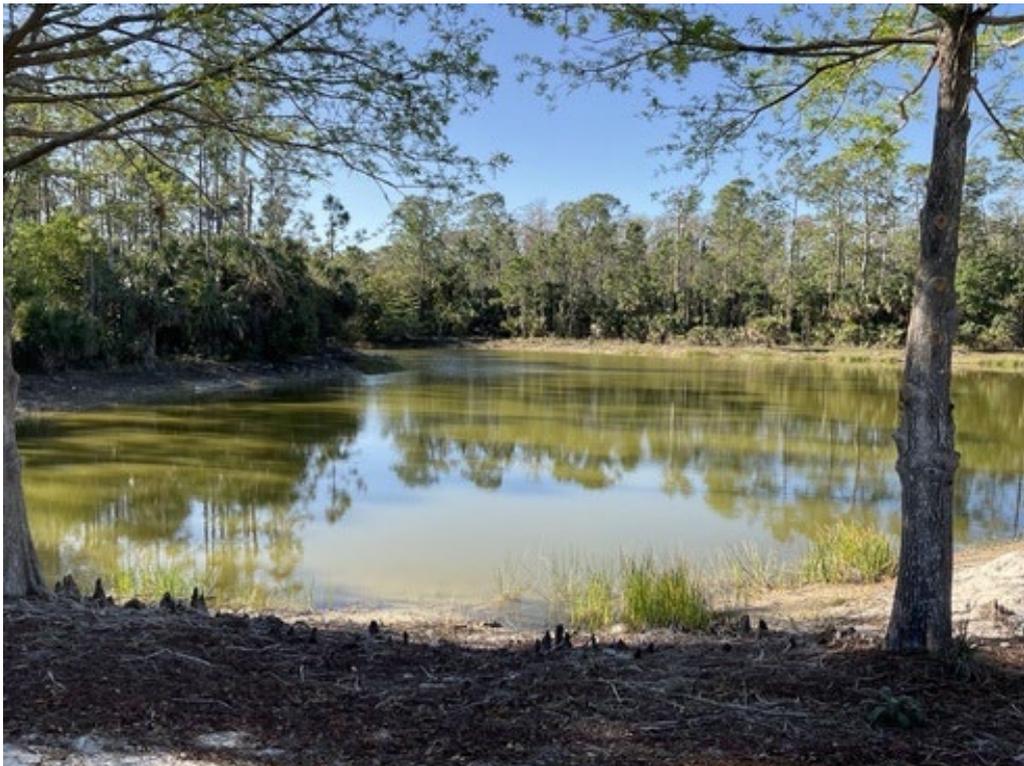
Photo 1

Airline break, repair expected before 3/28/25
