**MINUTES OF MEETING
MEDITERRA
COMMUNITY DEVELOPMENT DISTRICT**

Continued Discussion: M.R.I. Underwater Specialists, Inc. 2020 Drainage Inspection

TO: Mediterra CDD Board of SupervisorsDATE: 06/15/2020FROM: Andy TiltonRE: Brendisi Way Drainage

Outfall ROV Video Inspection

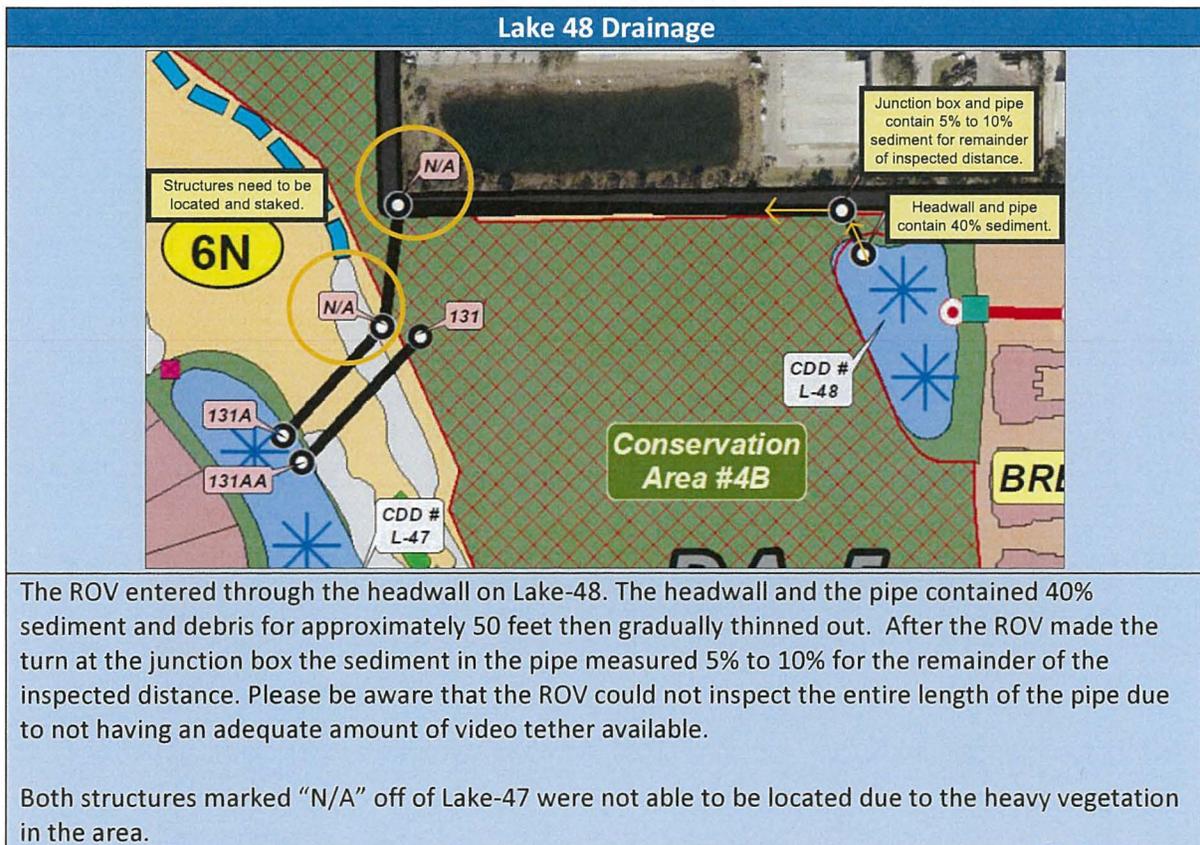
Lake 48

Mr. Bishko asked if there were plans to address the barren lake banks near the golf course and other areas and discussed how 50’ of blocked pipe, at Lake #48, would be removed. Mrs. Adams stated that the rocks on numerous lake banks, throughout, prevent vegetation from growing. Discussion ensued regarding blockages at OS-Oak 2, policies directing Staff to proceed with having work performed once a certain threshold was met, etc. Mr. Bishko felt it should be noted, on record, that the Board reviewed and discussed this item and that action would take place, since it was an agenda item. Mrs. Adams would coordinate to have the repairs noted in the report completed.
