**MEDITERRA**  
**COMMUNITY DEVELOPMENT DISTRICT**  
OFFICE OF THE DISTRICT MANAGER  
9220 Bonita Beach Road, Suite #214  
Bonita Springs, FL 34135

**MEMORANDUM**

Date: April 16, 2025  
To: Mediterra Board of Supervisors  
From: Shane Willis – Operations Manager  
Subject: Quality Assurance Inspection – Lake Maintenance  
Cc: File

# STORMWATER QUALITY ASSURANCE INSPECTION

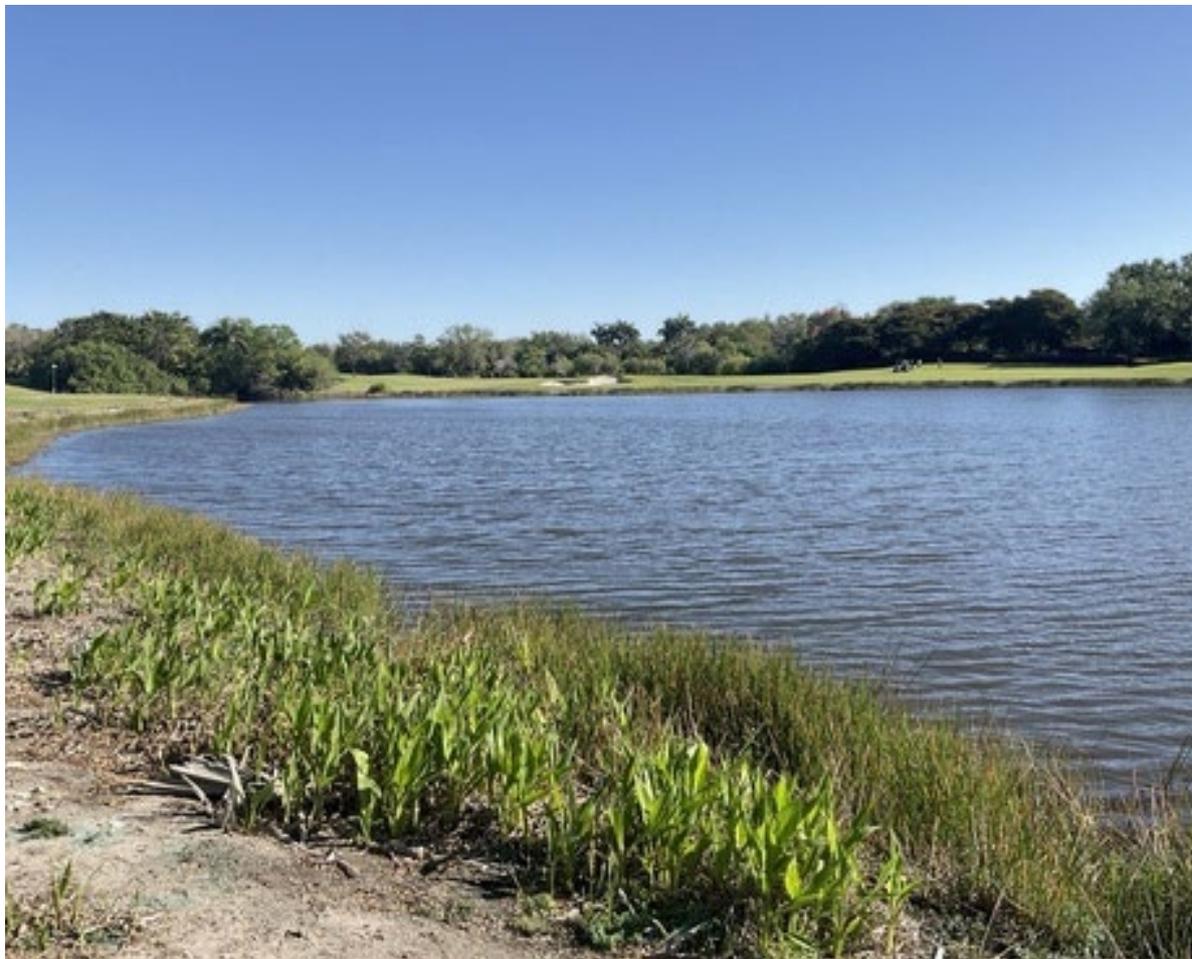
Photo 1

AUDIT CHECK POINTS	
Does invasive/undesirable plant control meet contract specifications? <b>Minor Bank Weeds, Weeds in Rip Rap</b>	Yes
Does beneficial plant population meet regulatory requirements?	Yes
Are existing beneficial plants healthy?	Yes
Is the lake absent trash?	Yes
HEALTH/SAFETY	
Is the lake surface absent any oil, grease or gas sheen?	Yes
Wildlife Observed	Anhinga
Does the overall lake body appear healthy?	Yes

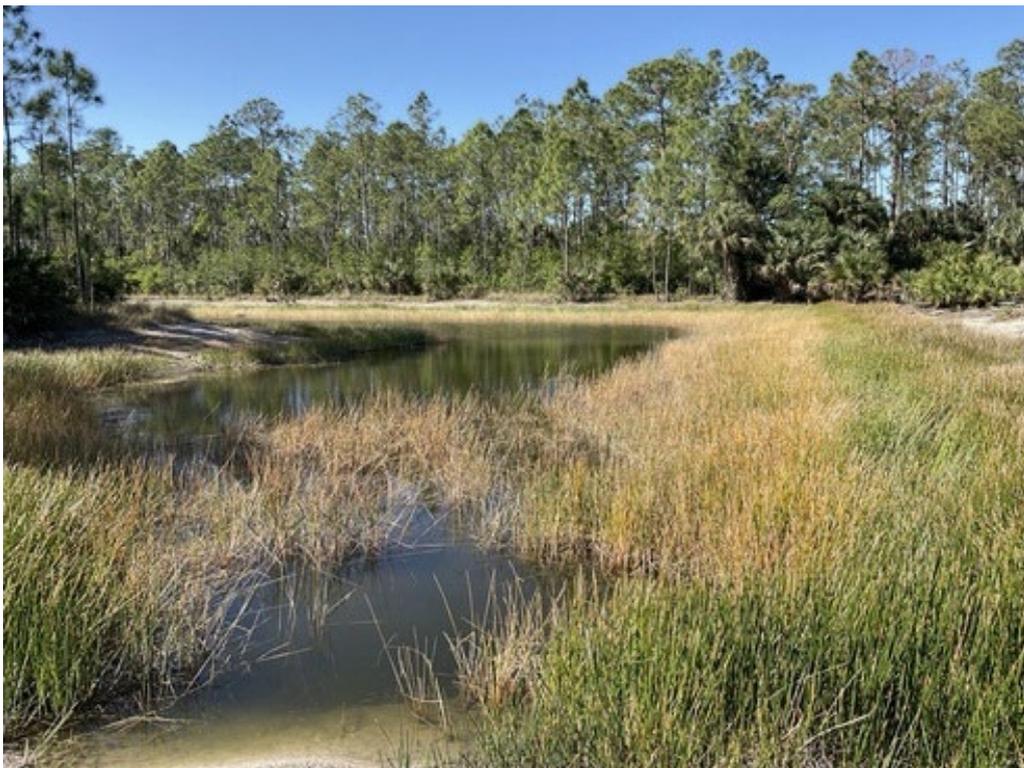
Photo 1

Does invasive/undesirable plant control meet contract specifications?	Yes
Does beneficial plant population meet regulatory requirements? Spike Recently Treated	Yes
Are existing beneficial plants healthy?	Yes
Is the lake absent trash?	Yes
HEALTH/SAFETY	
Is the lake surface absent any oil, grease or gas sheen?	Yes
Wildlife Observed	Fish
Does the overall lake body appear healthy?	Yes

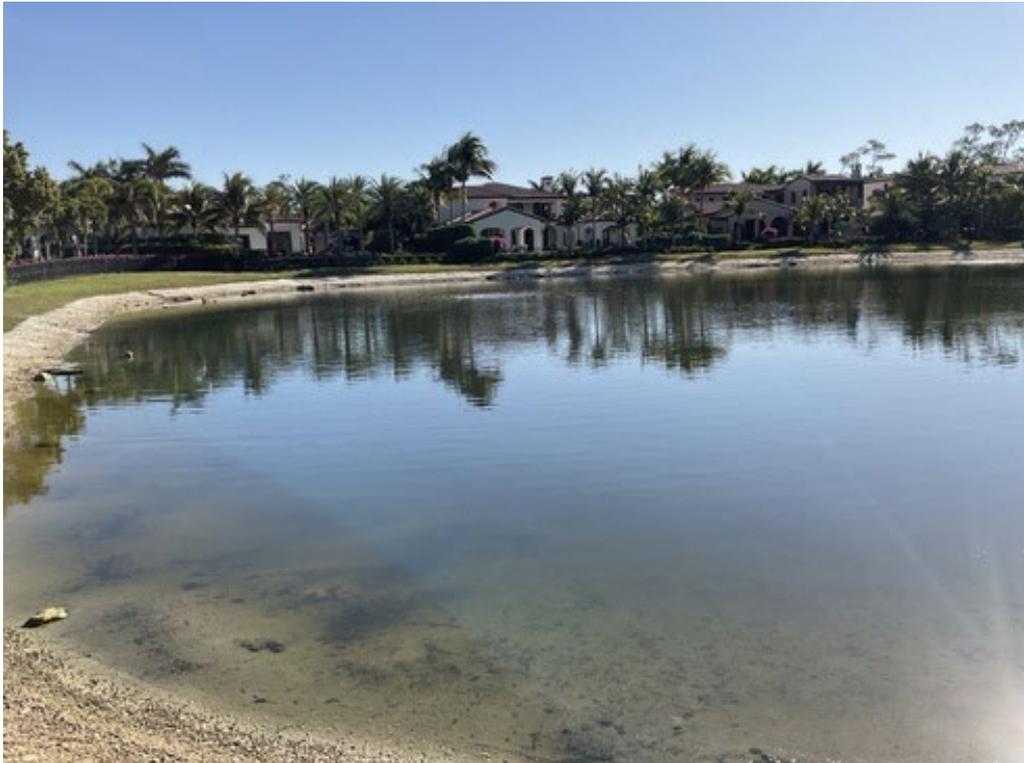
Photo 1

STRUCTURAL INTEGRITY	
Is the lake bank absent significant washouts?	Yes
Is the lake/lawn transition area absent drop offs greater than 8 inches	Yes
Lake bank restoration complete waiting for sod	
Are structures in sound and appropriate lifecycle conditions?	Yes
